## THE FORGOTTEN PARTS OF MAIN ENGINE

**OKTO ENGINEERING**

SL08-492/JVG  
March 2008**Rubber Diaphragm Sealings in Crankcase Oil Outlets**

## The "forgotten" rubber membrane

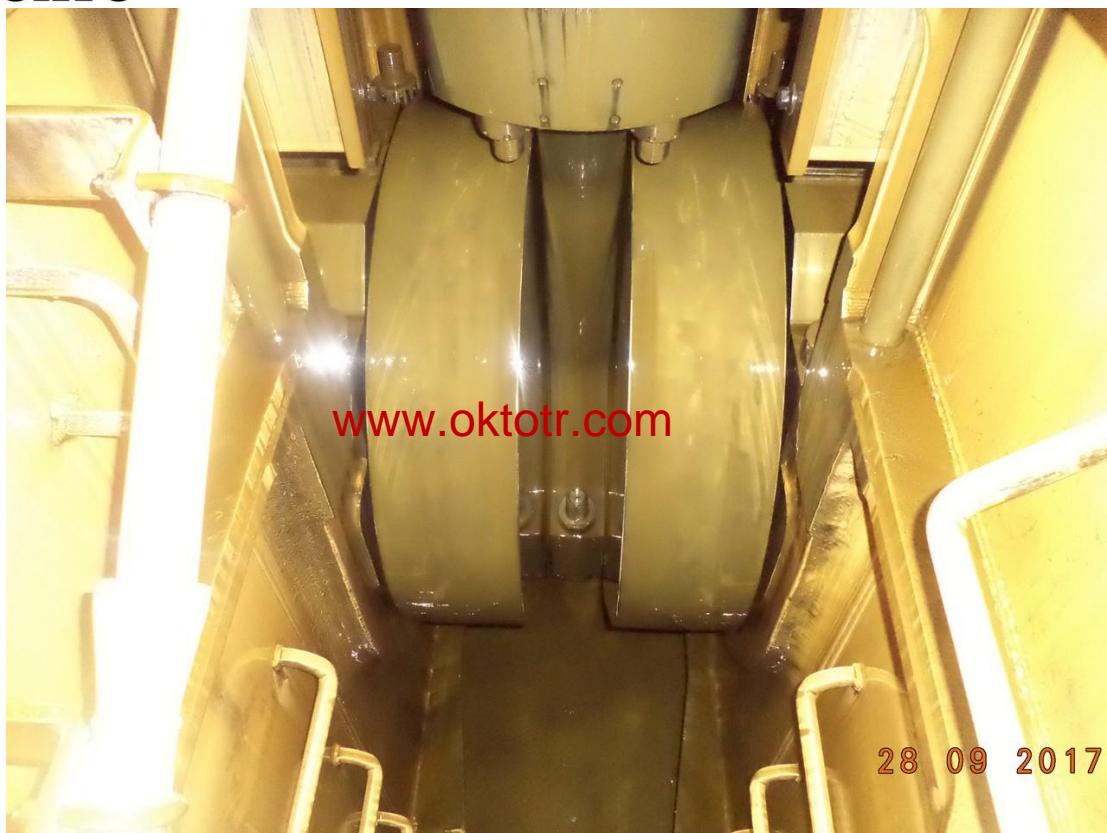
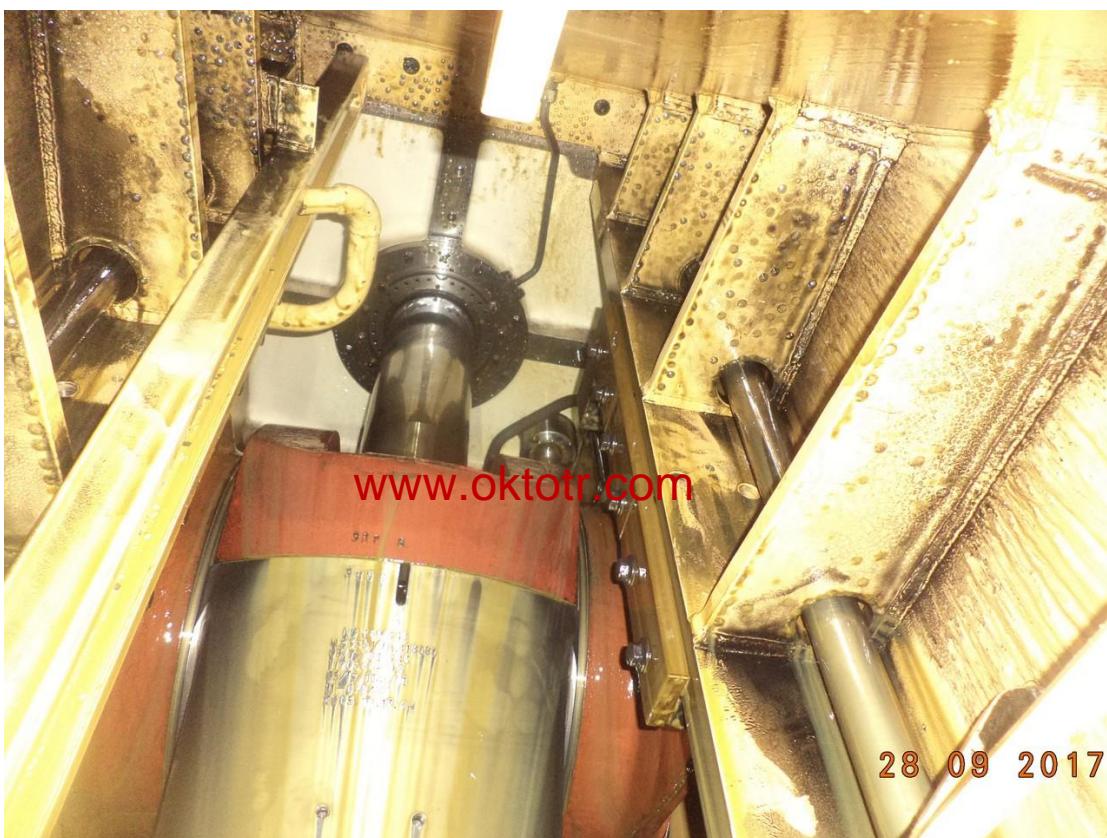
While we were opening main engine bearings for class inspection during vessel in drydock, everything seems good such as appearance oil, cleanliness of crankcase etc. Upon completing of job, we left vessel and come back a few days after launching. Once we open crankcase door for deflection measurement, (which vessel already started lubrication oil pump before our arrival) we have observed that lubrication oil deteriorated from excessive water in the lubrication oil system, which result replacing whole lubrication oil in the system.

After further investigation, we found out reason as extreme water presence on tank top (between main engine and sump tank) and damaged diaphragm membrane. Since vessel at drydock and crew busy for hectic jobs, ignored bilge alarm raised from M/E sunken part and could not realise water accumulation below main engine.

1. Best way to follow service letter and inspect/replace the defective parts.
2. Emphasize importance to keep tank top dry and pay special attention to alarm raised from M/E sunken area, especially during drydock period. Please see below pictures belongs to above experience.

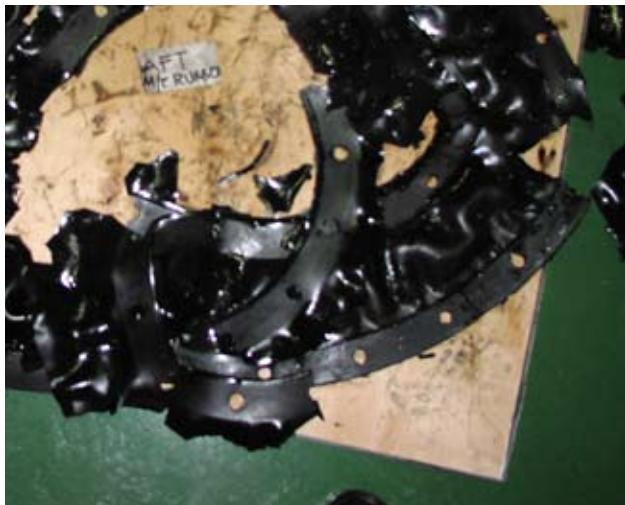
It has come to the Club's attention during the launched investigation in one of the cases, that the rubber membranes were not oil resistant, which eventually caused complete failure of the membranes. In other cases the rubber membranes failed due to natural aging process.

Defective rubber membranes may cause severe engine damage.

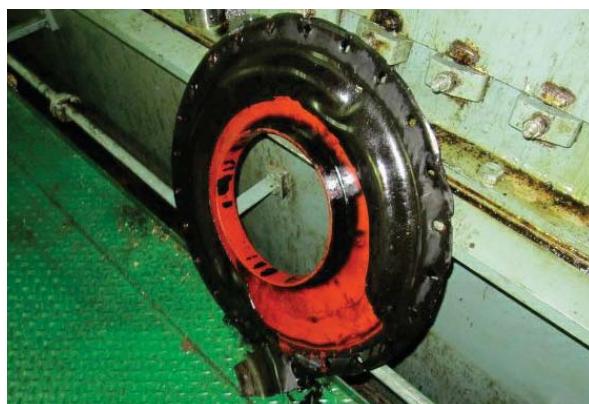
Failed diaphragm

In line with the recommendation issued by MAN Diesel A/S, Copenhagen, we recommend that all diaphragms are replaced in connection with every relevant scheduled inspection of the ship.

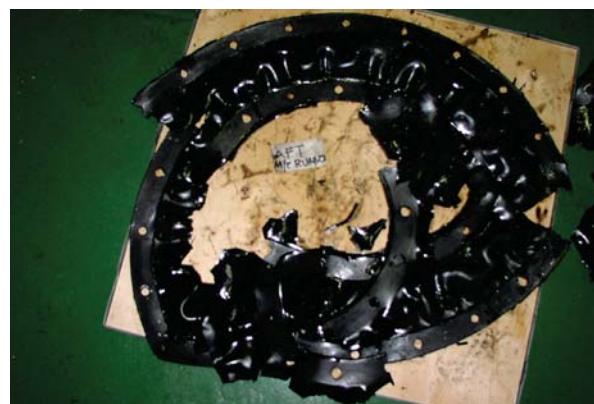
Deteriorated diaphragm
