## THE FORGOTTEN PARTS OF MAIN ENGINE

**OKTO ENGINEERING**

SL08-492/JVG  
March 2008**Rubber Diaphragm Sealings in Crankcase Oil Outlets**

## The "forgotten" rubber membrane

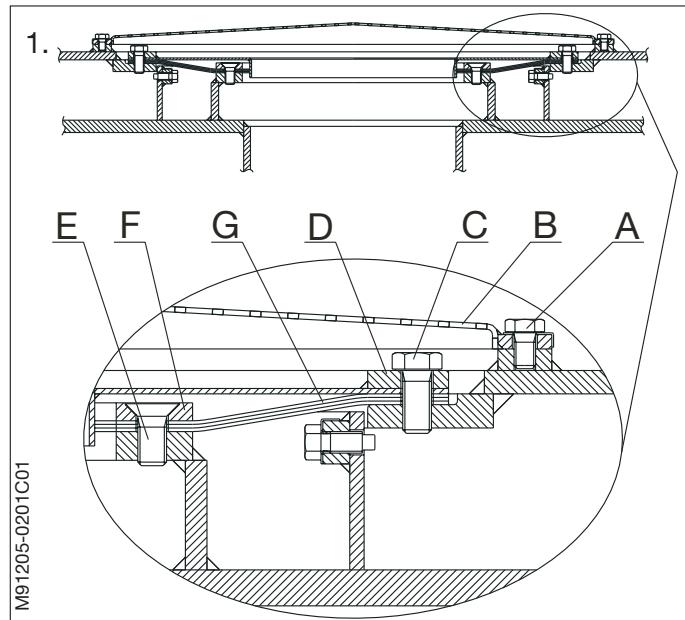
### Rubber diaphragm sealing

If the water content of the main engine lube oil is rising, this may indicate that the crankcase oil outlet sealings are fractured.

1. To access the rubber diaphragm sealing remove:  
Screws A  
Grating B  
Screws C  
Cover plate D  
Screws E  
Steel ring F.
2. Lift away the rubber sealing diaphragms G and examine each diaphragm closely. In case of any rips or tears in the diaphragms, they must be replaced.

It is strongly recommended to always replace the diaphragms during inspection.  
If unavailable, new diaphragms may be made from three layers of 2 mm thick oil and temperature resistant rubber.

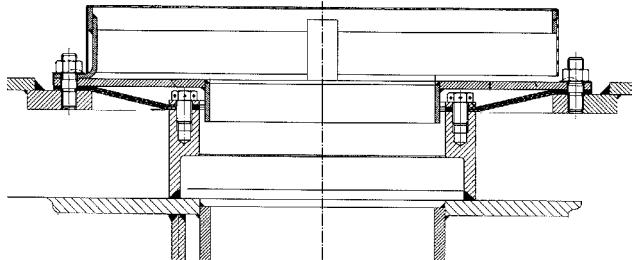
It is rather clear that the design of Wärtsilä/Sulzer and MAN Diesel A/S in this respect are similar, and as a consequence they are both potentially exposed.

Design of the Wärtsilä/Sulzer sump tank connection.

**Wärtsilä/Sulzer's recommendation is as follows:**  
 inspection of this part at 40,000 running hours, during a dry dock and replace it if it's damaged.

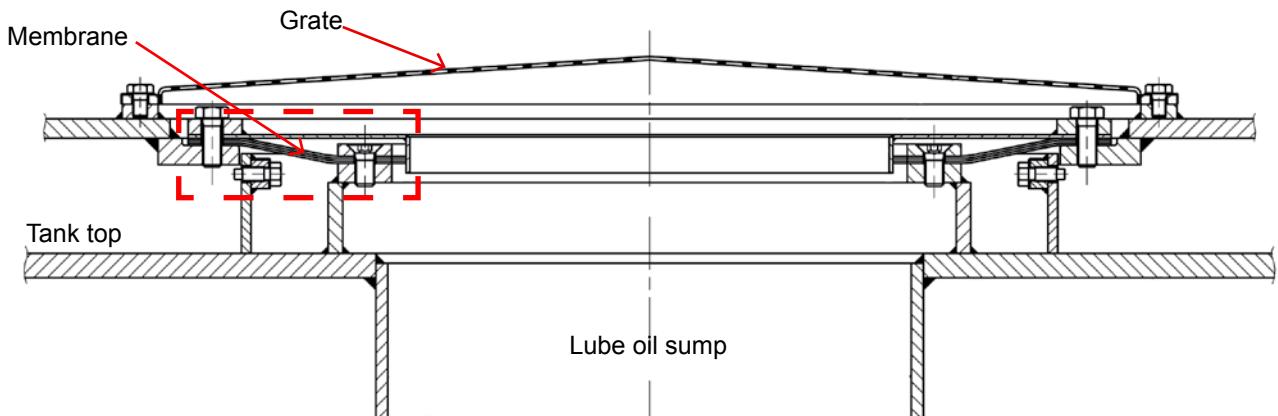
## The forgotten Rubber membrane

It has come to the Club's attention during the launched investigation in one of the cases, that the rubber membranes were not oil resistant, which eventually caused complete failure of the membranes. In other cases the rubber membranes failed due to natural aging process.

In both cases described above excessive quantities of water on the tank top entered the main engine sump tank, and subsequently contaminated the main engine lubricating oil system, resulting in severe damage to the main engine bearings.

*The Swedish Club and MAN recommend you to replace the membrane at each dry-docking and also keep extra membranes on board.*

MAN Diesel A/S, Copenhagen, has recently issued a more comprehensive recommendation to replace all membranes in connection with each dry-docking of the vessel.

**MAN Diesel A/S, Copenhagen, recommends:** in order to avoid water entering the main engine sump tank through a defect in the crankcase oil outlet:

- Inspect the diaphragm sealing in crankcase oil outlet every 32,000 hours of operation and replace the diaphragm if it is indicated by the observation. Always replace in case of a rubber diaphragm.
- Inspect the diaphragm sealing at the earliest opportunity after delivery of a new-building. In case of a rubber diaphragm make sure the material is oil resistant and replace if this is not the case.
- Inspect the diaphragm sealing at the earliest opportunity when taking delivery of an existing ship and replace the diaphragm if it is indicated by the observation. Always replace in case of a rubber diaphragm.

In line with the recommendation issued by MAN Diesel A/S, Copenhagen, we recommend that all membranes are replaced in connection with every relevant scheduled inspection of the ship.

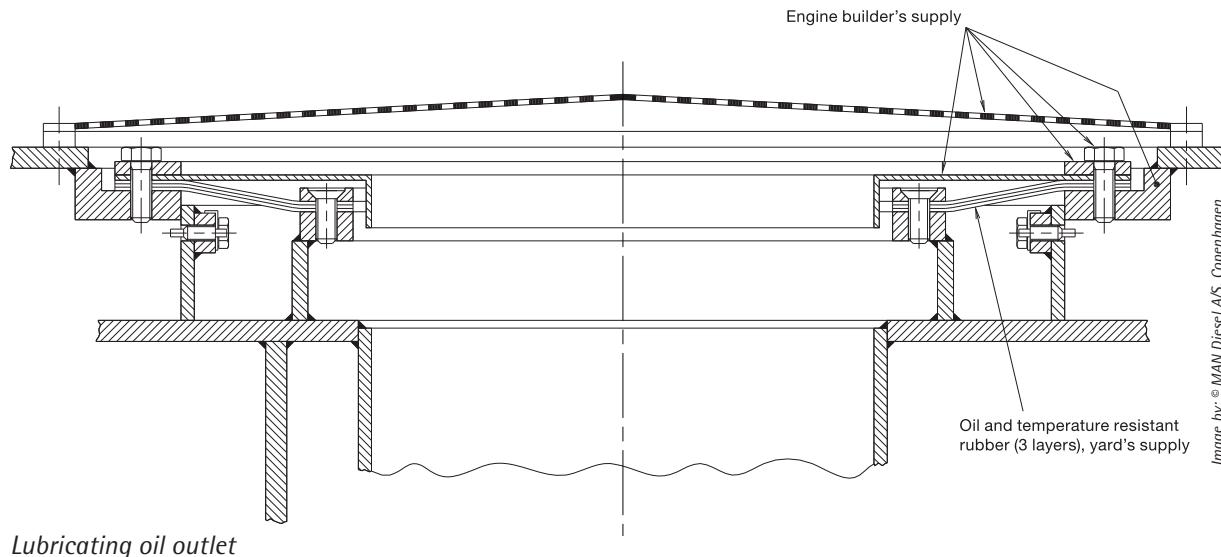
In all cases excessive quantities of water on the tank top have entered the main engine sump tank via the defective diaphragm and subsequently contaminated the main engine lubricating oil system, resulting in severe damage to the main engine bearings and journals.

Deteriorated diaphragm

- ▶ Inspection/replace at 40,000 running hours or at dry dock.
